# LAKE TRANQUILITY DAM

**NJ 00275**

## PHASE I INSPECTION REPORT NATIONAL DAM SAFETY PROGRAM

11 MARCH 1981

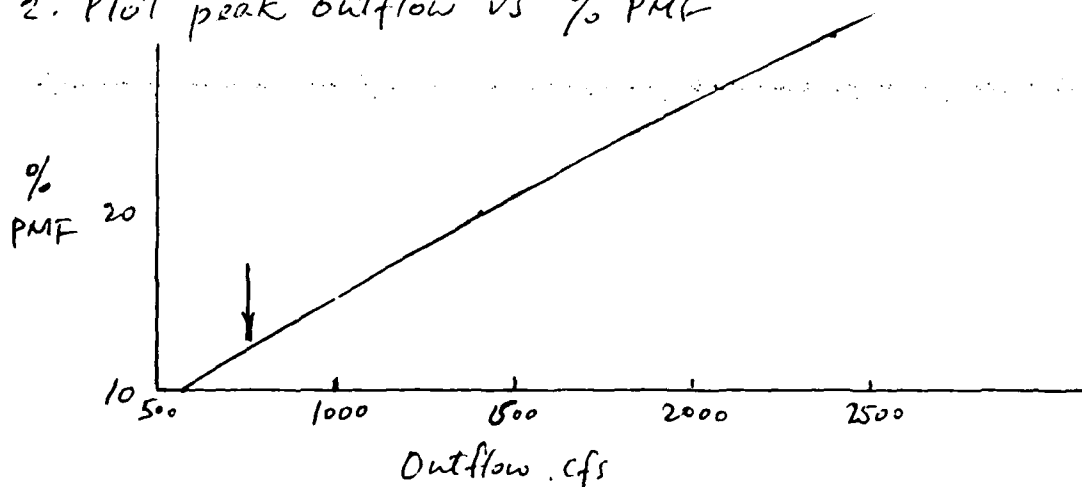
## OVERTOPPING POTENTIAL

3. Dam overtops at elevation 102 with  $Q = 767$  cfs  
 $\therefore$  dam can pass approx. 12% of the PMF.
